Focusing on pipeline construction products using PRINCE2®

Michael Warman

Case study
June 2020

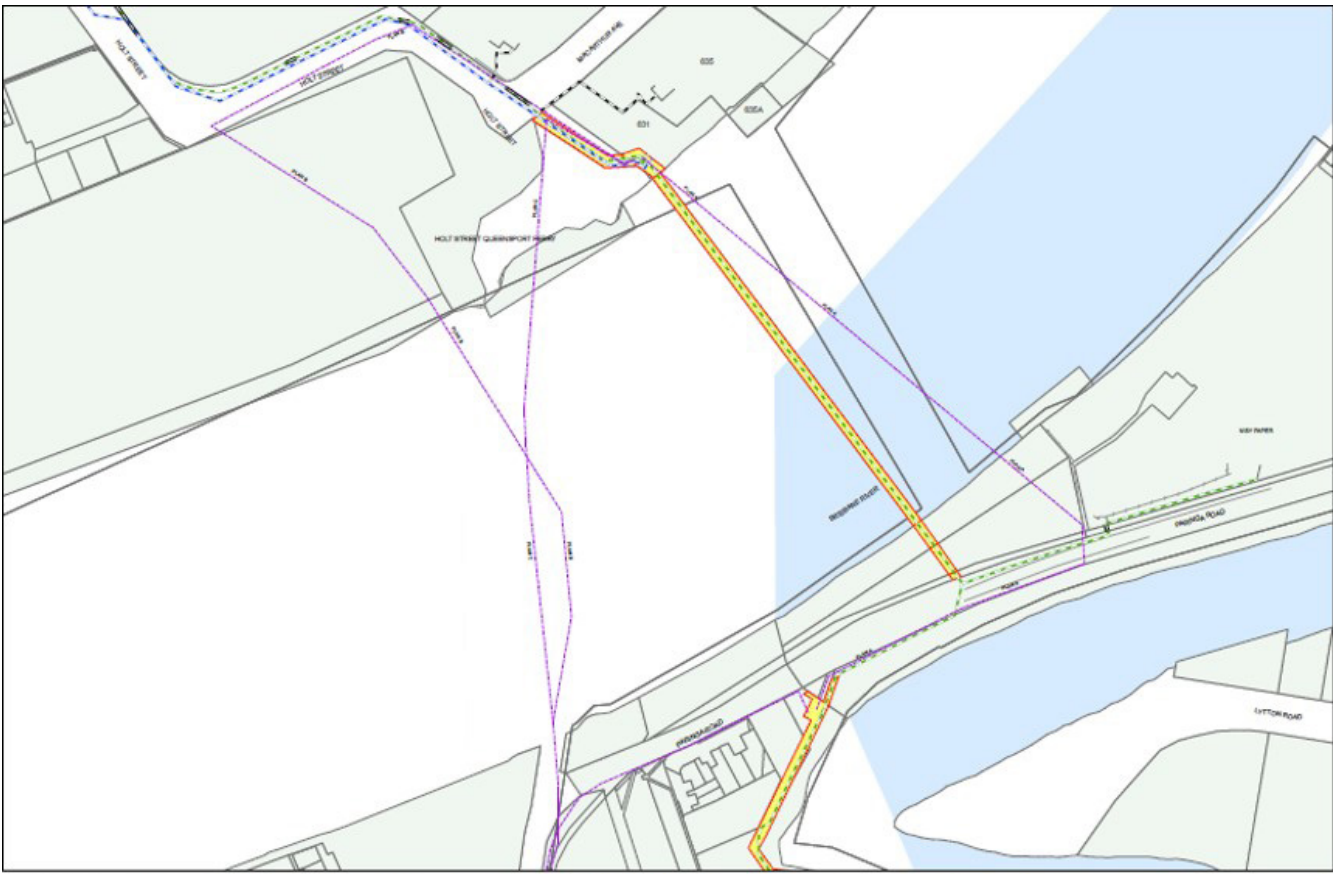
Figure 2.1 Concept for Brisbane River Crossing options 1, 2 and 3

Detailed design progressed with the river design and was finalized in April 2018 as shown in Figure 2.1. APA group sought a third-party review, which the design successfully passed; this brought the successful completion of the first stage of the project.

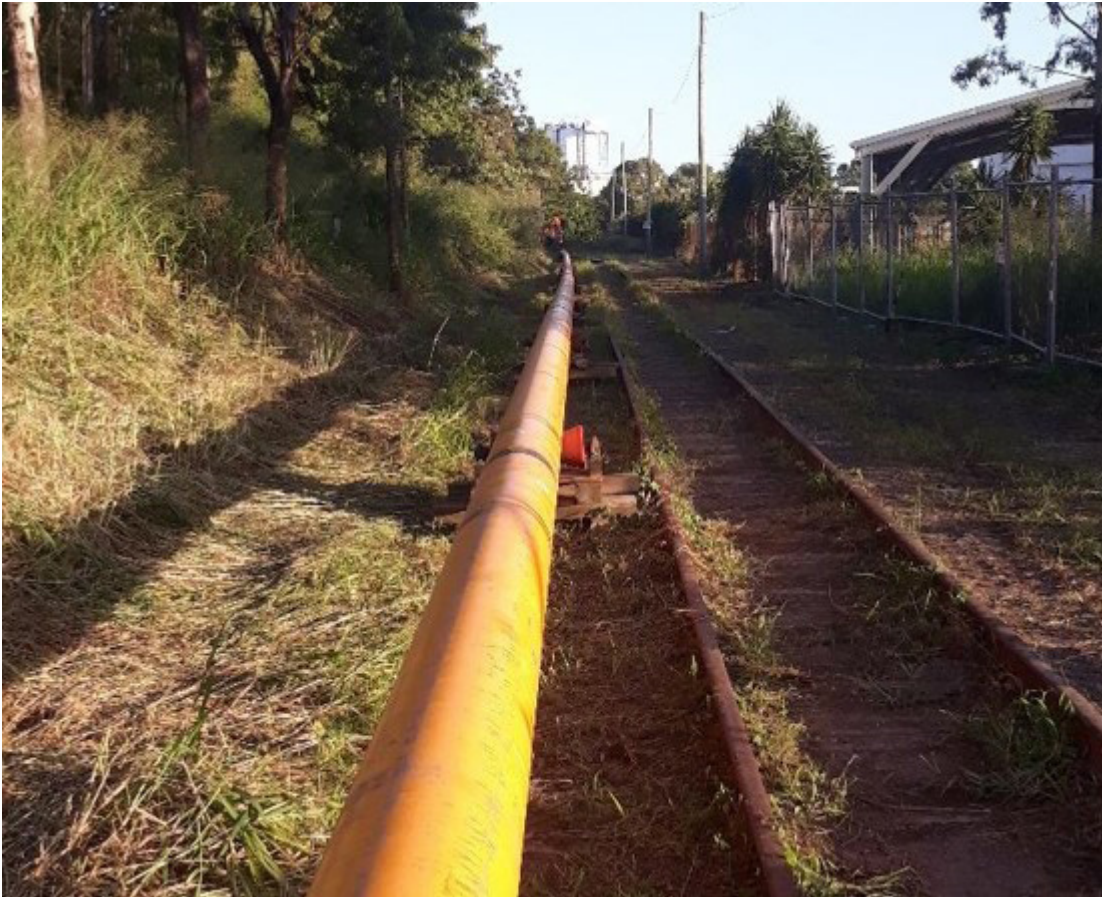
Figure 4.1 The right of way used for the HDD sting construction

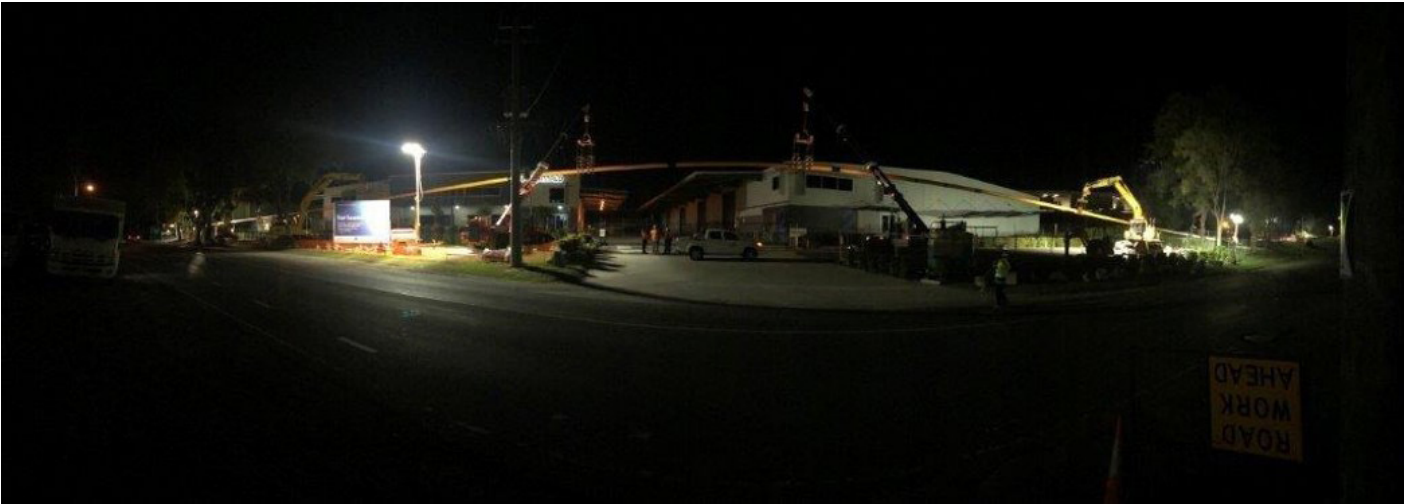
Figure 4.2 Sting elevation over commercial drive during pull back activities

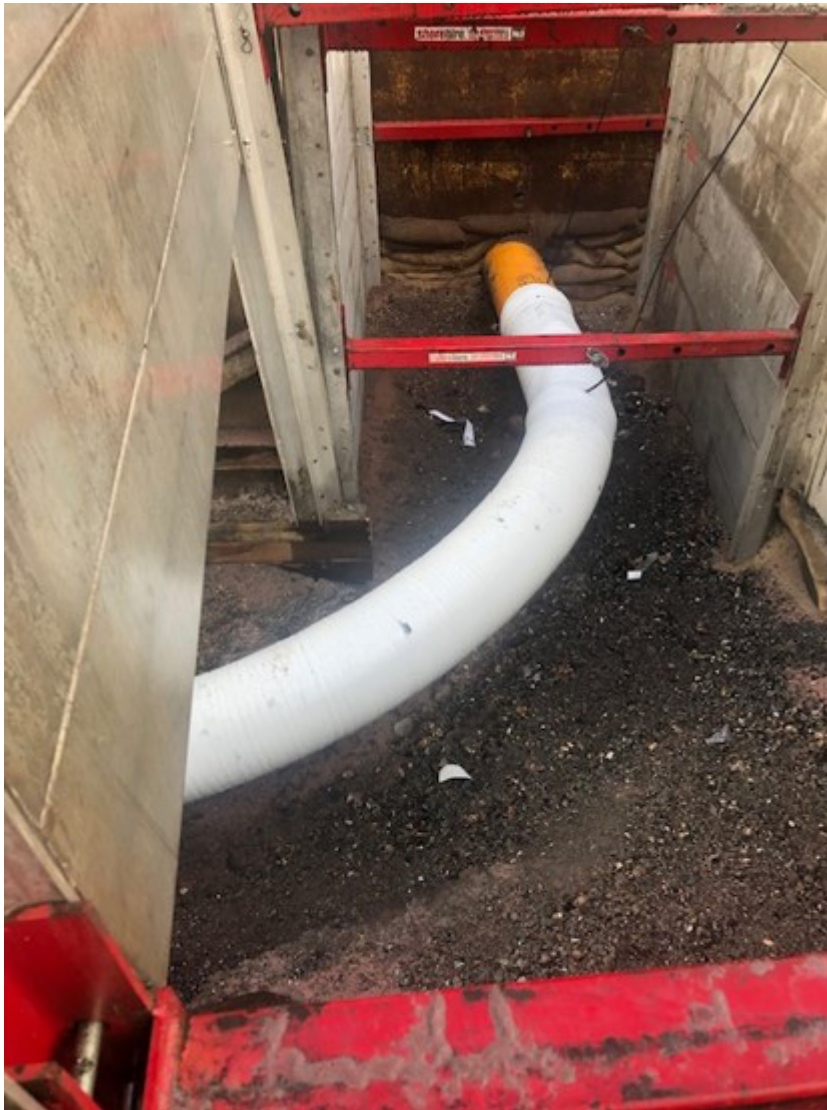
Figure 4.3 5 times diameter hot rolled induction bend installed with corrosion protection wrapping installed prior to backfill
